## Title : Assessment of Loading Capacity Fire-Fighting-Platform

**Speaker** R.P. Roggeveld MSc (Structural Engineer / Speaker)  
**Co-Authors** F.J. Kaalberg MSc  
**Firm** Witteveen+Bos, The Netherlands

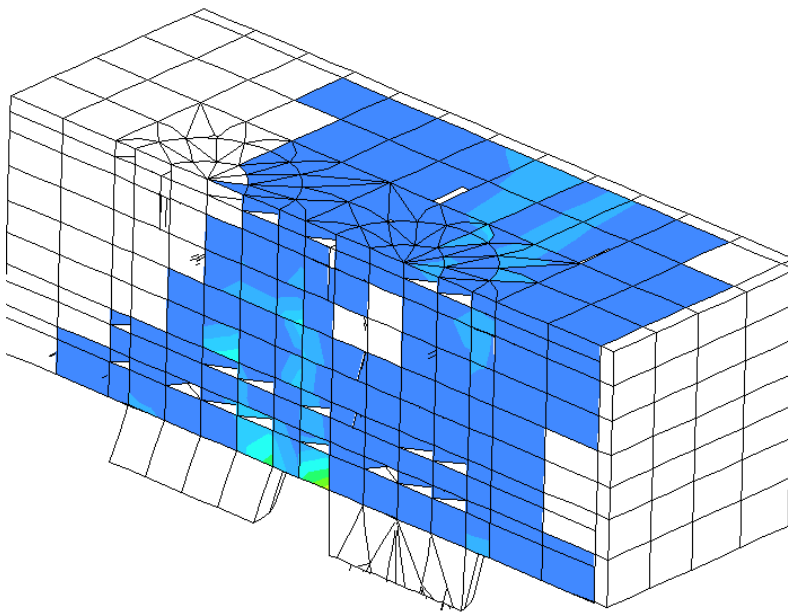
Figure 1: cross-section of platform corner, showing crack development
