Title: Stability assessment of a masonry arch

Speaker R.P. Roggeveld MSc (Structural Engineer / Speaker)

Firm Witteveen+Bos, The Netherlands

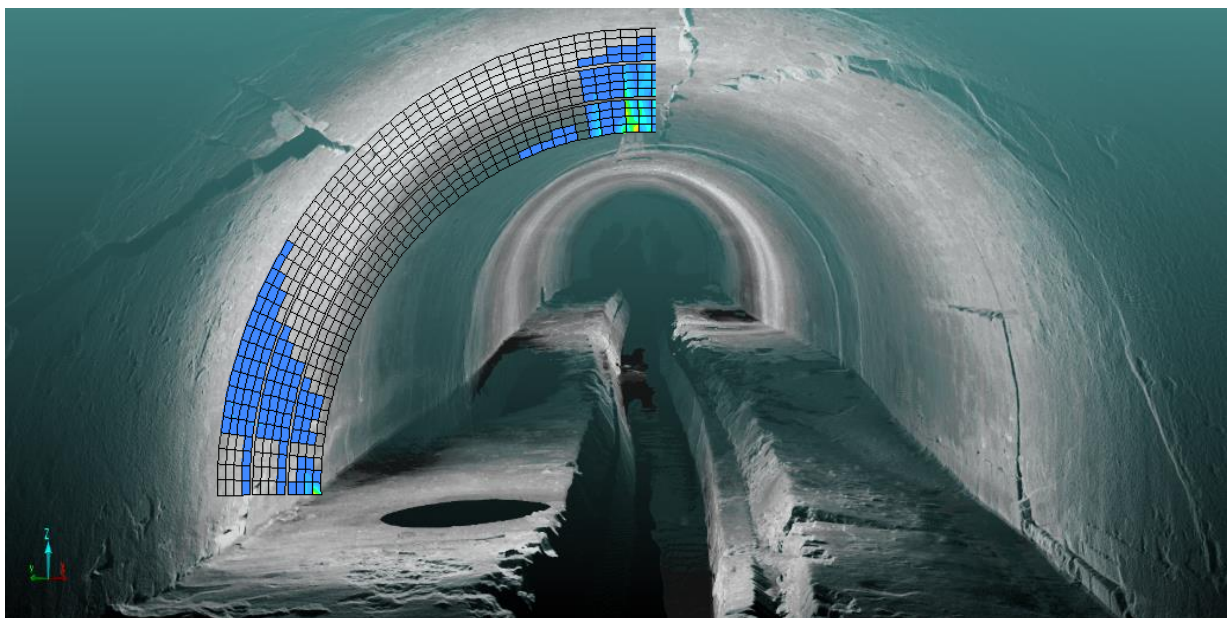
Figure 1: Diana-results, combined with a picture and laser scan

Geometrical and physical non-linear Diana-models were used to assess the stability of the arch under various circumstances, for instance due to variance in soil stiffness, wall thickness and material degradation.
