EXPERIMENTAL AND NUMERICAL ASSESSMENT OF HISTORICAL STEEL-CONCRETE COMPOSITE BRIDGE DECKS WITHOUT MECHANICAL CONNECTORS

Mauro Pollotti¹, Yuguang Yang¹, Ane de Boer^{2,3},
¹Concrete Structures, Delft University of Technology, Delft, The Netherlands
²Ane de Boer Consultancy, Arnhem, The Netherlands
³Municipality of Amsterdam, Amsterdam, The Netherlands

DIANA USERS ASSOCIATION – 15/09/2022

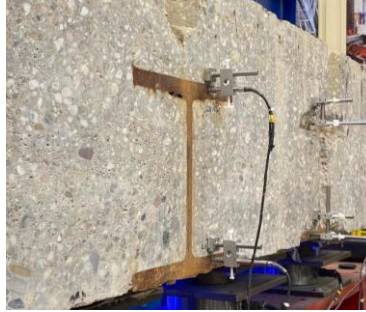
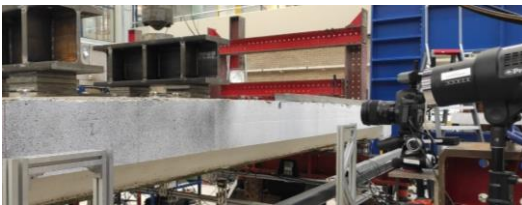
Measurement Plan

- 42 optic fibers
- 15 LVDTs
- 12 Lasers
- 6 reaction load cells
- 2D & 3D DIC

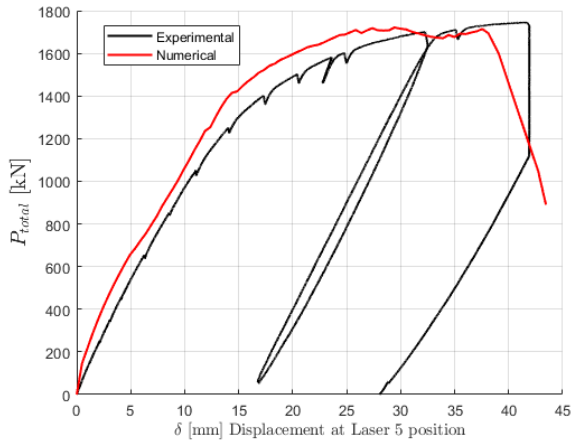
LB1 – SHORT Specimen L=5900 mm

Load Deflection
