# Omgevingsbeïnvloeding

- zettingsschade aan
- belendende panden -

**Dipl.- Ing. H. Netzel**

CRUX Engineering b.v.  
TU Delft Faculteit der Bouwkunde  
Delft Cluster

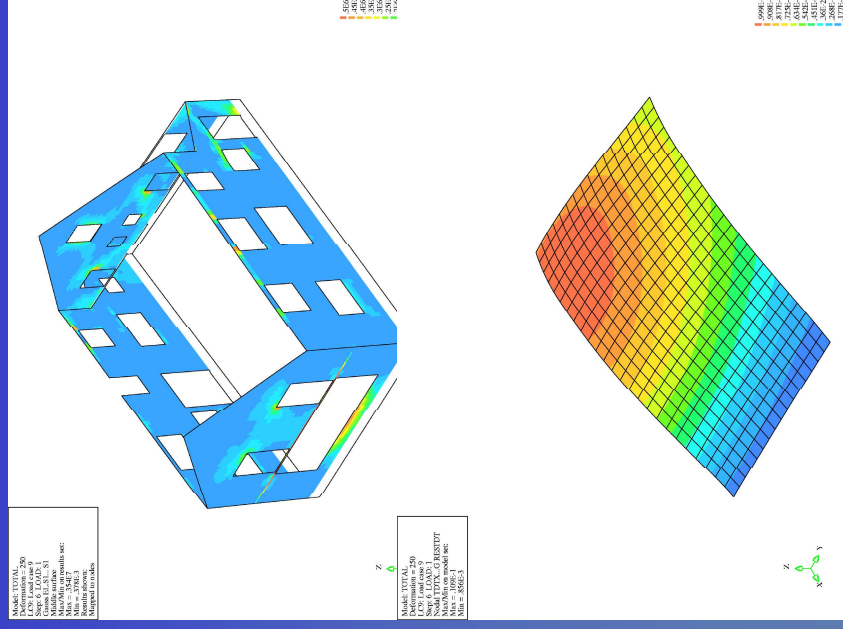
Scheurvorming
